# ELK-M1 CONTROL RELEASE NOTES

## June 23<sup>rd</sup>, 2022 - M1 Firmware 5.3.14 Evaluated and Listed by UL

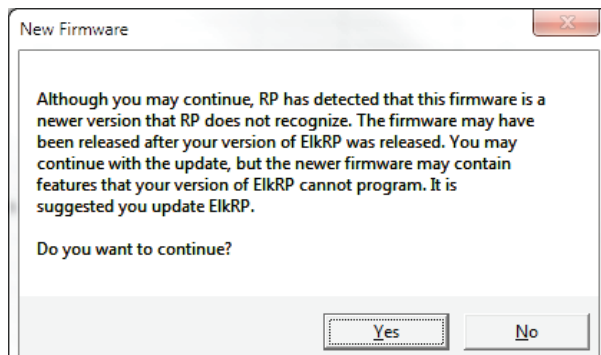
This "New Firmware" message may appear upon connection if ElkRP does not recognize the new version of M1 firmware. There is no great need for concern. This is generally just a case where ElkRP has not yet been updated to reflect the newer M1 firmware version.

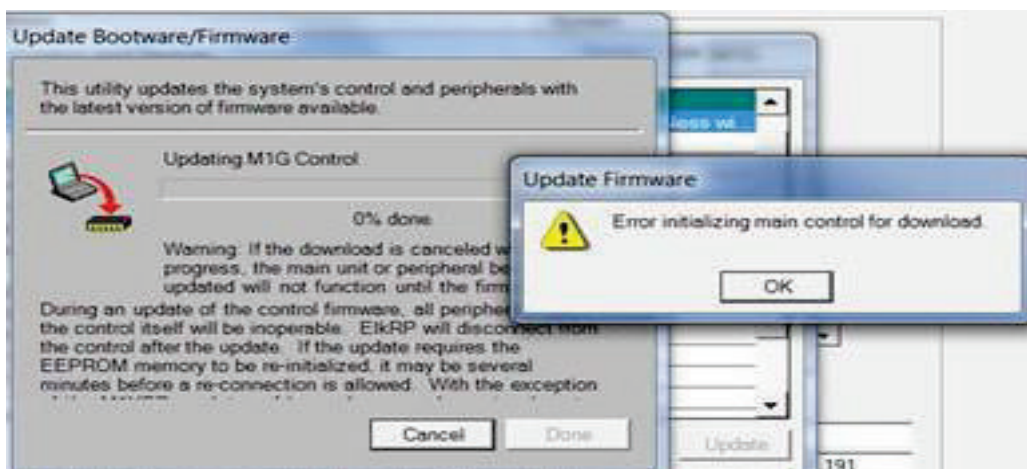
ElkRP versions 2.0.24 and beyond will not allow a bus module enrollment or flash memory update to be performed if any area is armed. To enroll or do a flash update it will be necessary to disarm all areas, do the enroll or flash update, then re-arm. This change was implemented in the interest of enhanced security. The warning or error message displayed will depend on the version of ElkRP that you are currently using.
